**Flood Control Project Maintenance
Levee Inspections**

Maintenance Issue Types Only, Levee Inspection Report By Mile - Fall 2018

Sutter Maintenance Yard Maintenance Area 0001

Waterway	Bank	Unit Miles	Inspection Start/End	Inspector
Unit No. 01 Sacramento River	Right	16.76	10/04/2018 10/04/2018	Bob Duffey

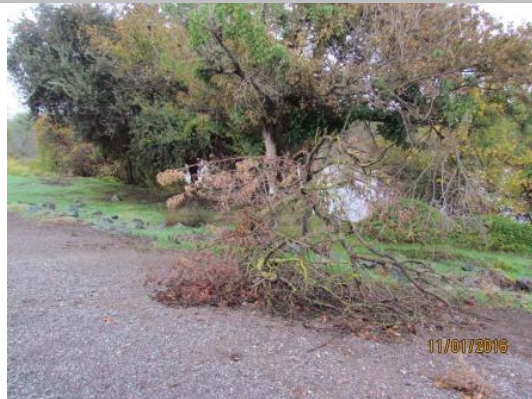
Photo 1 of 1 : FA_2018_MA0001_297_93_20180905_00026.jpg

LM Start	0.07	Rating **	M	Issue No.	93
LM End	0.07	Issue Type +	Ma	Location *	WS
Category	Earthen Levee			GPS Latitude/Longitude	
				Start	End
Item	Encroachments			39.214162°	39.214162°
				-122.002158°	-122.002158°
DWR ID	DWR_MA0001_01_f_2016_93				
Comment Code					
TR : Tree or limb					
Inspector Comment

View of a tree limb along the waterside slope.

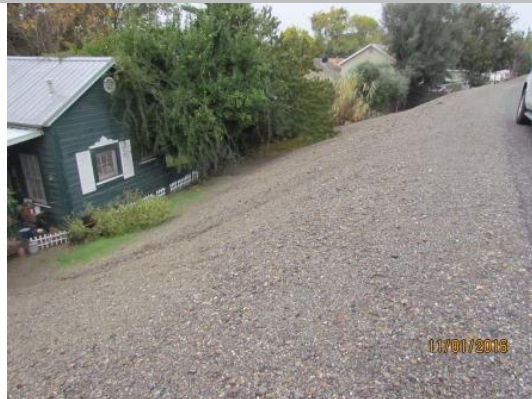
Photo 1 of 1 : FA_2018_MA0001_297_94_20180905_00027.jpg

View of the slope instability along the landside slope.

LM Start	0.09	Rating **	M	Issue No.	94
LM End	0.09	Issue Type +	Ma	Location *	LS
Category	Earthen Levee			GPS Latitude/Longitude	
				Start	End
Item	Slope Stability			39.214217 °	39.214217 °
				-122.002378 °	-122.002378 °
DWR ID	DWR_MA0001_01_f_2016_94				
Comment Code					
S2 : Repair the levee slope damaged by foot traffic and prevent access where possible.					
Inspector Comment					
Repair the erosion along the damaged slope.

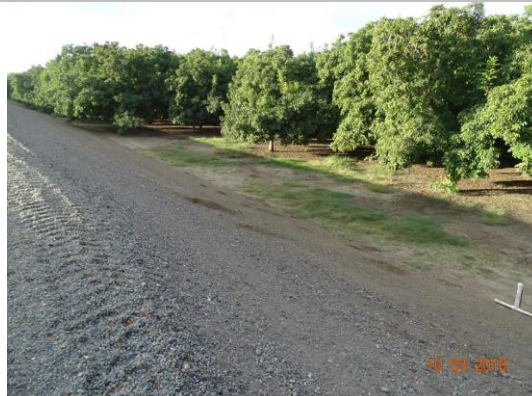
Photo 1 of 1 : FA_2018_MA0001_297_68_20181005_00150.jpg

View of the rodent holes along the landside slope.

LM Start	1.87	Rating **	M	Issue No.	68
LM End	1.87	Issue Type +	Ma	Location *	LS
Category	Earthen Levee			GPS Latitude/Longitude	
				Start	End
Item	Animal Control			39.231195°	39.231195°
				-122.015460°	-122.015460°
DWR ID	DWR_MA0001_01_f_2018_68				
Comment Code					
A3 : No rodents visible, but rodent burrows visible; need to backfill and compact or grout burrows.					
Inspector Comment					
Repair the rodent holes along the landside slope.

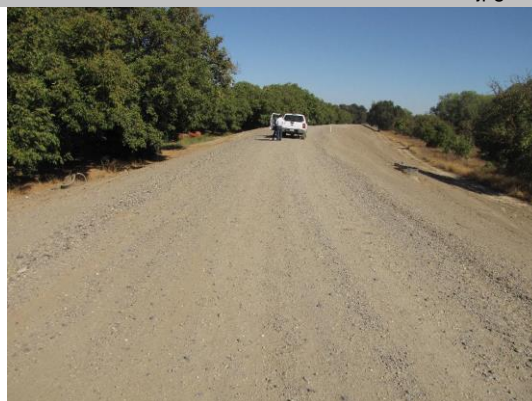
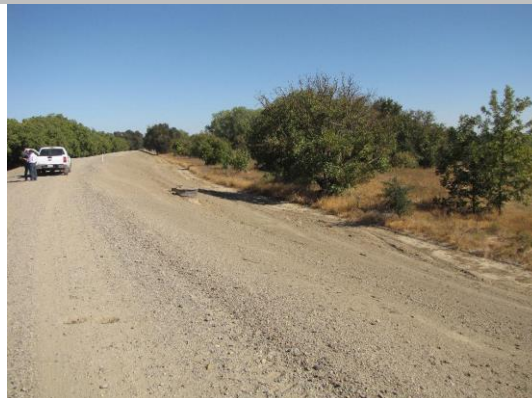
Comment Code						
Inspector Comment						
FS_ID:51852 DS_ID:16430 EP_NO: 9487 Repair Type: Non-Urgent Crossing Status: Found UCIP Comments: 5/3/2017 WS end still partially plugged. (DWR Sutter Yard- A Freitag)10/24/2016 Ws end is till partially plugged.(DWR Sutter Yard- A Freitag)4/25/2016 WS pipe end is still plugged with soil. Rest of the pipe appeared to be in good condition.4/20/2015 WS pipe end is plugged about 50% by soil.6/18/2014 Same as last inspection.12/17/2013 Same as last inspection.7/18/2013 WS pipe end has been reformed but is still clogged about 50% by sediment.10/18/2012 Remove dirt and debris in riser. Outlet deformed and blocked over 50%. Debris-round concrete section on landward side. This crossing was listed in the USACE Periodic Inspections as ID# USACE_CESPK_MA1C_2010_p_0116 for crossing outlet deformed and clogged with dirt. FIELD_STRUCT_DESC: 1 of 2: 36-inch corrugated metal drainage pipe through the levee, approximately 12-15 feet below the crown. Slide gates in corrugated metal pipe (CMP) riser located on the waterside (WS) slope. Pipe daylights on the landside (LS). (36-inch pipe [HLM 1.97] authorized under Automatic Board Order (ABO) issued as Permit No. 9487, 1974 - Jimeno Rancho) [Additional Reference(s): DWR Levee Log, 1992. USACE Sacramento O&M Manual 137, August 1955, (Station 103+18)]. FS Date: 5/19/2017 1:20:29 PM

FS_ID:51852
DS_ID:16430
EP_NO: 9487
Repair Type: Non-Urgent
Crossing Status: Found
UCIP Comments: 5/3/2017 WS end still partially plugged. (DWR Sutter Yard- A Freitag)10/24/2016 WS end is still partially plugged. (DWR Sutter Yard- A Freitag)4/25/2016 WS pipe end is still plugged with soil. Rest of the pipe appeared to be in good condition.4/20/2015 WS pipe end is plugged about 50% by soil.6/18/2014 Same as last inspection.12/17/2013 Same as last inspection.7/18/2013 WS pipe end has been reformed but is still clogged about 50% by sediment.10/18/2012 Remove dirt and debris in riser. Outlet deformed and blocked over 50%. Debris-round concrete section on landward side. This crossing was listed in the USACE Periodic Inspections as ID# USACE_CESPK_MA1C_2010_p_0116 for crossing outlet deformed and clogged with dirt.
FIELD_STRUCT_DESC: 1 of 2: 36-inch corrugated metal drainage pipe through the levee, approximately 12-15 feet below the crown. Slide gates in corrugated metal pipe (CMP) riser located on the waterside (WS) slope. Pipe daylights on the landside (LS). (36-inch pipe [HLM 1.97] authorized under Automatic Board Order (ABO) issued as Permit No. 9487, 1974 - Jimeno Rancho) [Additional Reference(s): DWR Levee Log, 1992. USACE Sacramento O&M Manual 137, August 1955, (Station 103+18)].

View of WS looking upstream at CMP riser on slope.

View of LS looking upstream at crossing.

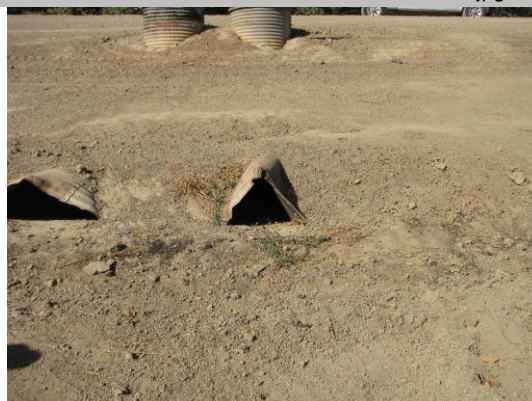
Photo 3 of 3 : UCIP_FA_2018_51853_70073.jpg

FS_ID:51853
DS_ID:17565
EP_NO: 9487
Repair Type: Non-Urgent
Crossing Status: Found
UCIP Comments: 5/3/2017 Ws end still partially plugged. (DWR Sutter Yard- A Freitag)10/24/2016 Ws pipe end still plugged.(DWR Sutter Yard- A Freitag)4/25/2016 WS pipe end still plugged with soil. rest of pipe appears in good condition.4/20/2015 WS pipe end plugged about 50% by soil.6/18/2014 Same as last inspection.12/17/2013 Same as last inspection.7/18/2013 WS pipe end has been reformed but is still partially blocked with dirt and debris.10/18/2012 WS-remove dirt and debris in riser. Outlet deformed and blocked over 50%. Burrow activity near outlet on waterward slope. Debris around concrete section on landward side. This crossing was listed in the USACE Periodic Inspections as ID# USACE_CESPK_MA1C_2010_p_0116 for crossing outlet deformed and clogged with dirt.
FIELD_STRUCT_DESC: 2 of 2: 36-inch corrugated metal drainage pipe through the levee, approximately 12-15 feet below the crown. Slide gates in corrugated metal pipe (CMP) riser on the waterside (WS) slope. Pipe daylights on the landside (LS). (36-inch pipe [HLM 1.97] authorized under Automatic Board Order (ABO) issued as Permit No. 9487, 1974 - Jimeno Rancho) [Additional Reference(s): DWR Levee Log, 1992. USACE Sacramento O&M Manual 137, August 1955, (Station 103+18)].

CMP pipe outlet deformed with over 50 percent blockage.

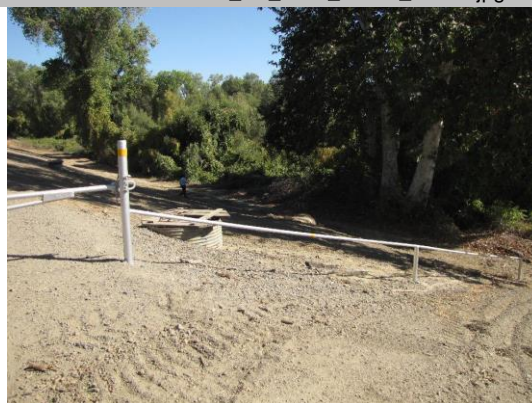
Comment Code					
Inspector Comment					
FS_ID:51854 DS_ID:16429 EP_NO: 9472 Repair Type: Non-Urgent Crossing Status: Found UCIP Comments: 5/3/2017 LS inlet partially plugged with soil. Some debris still present inside riser. (DWR Sutter Yard-AFreitag)10/24/2016 Debris still inside of riser.(DWR Sutter Yard-AFreitag)4/25/2016 Pipe still inside of riser and LS end plugged about 50% by soil.4/20/2015 Same as last inspection.6/18/2014 Same as last inspection.12/17/2013 Same as last inspection.7/18/2013 Same as last inspection.10/18/12 Remove debris from riser. Landward inlet is blocked by over 50%. This crossing was listed in the USACE Periodic Inspections as ID# USACE_CESPK_MA1C_2010_p_0128 for sediment build up at inlet (landward side) and debris inside riser. FIELD_STRUCT_DESC: 54-inch corrugated metal drainage pipe through the levee, approximately 12-15 feet below the crown. Slide gate in corrugated metal pipe (CMP) riser on the waterside (WS) slope. 48-inch CMP at landside (LS) slope. This crossing crosses the levee at an angle. (54-inch pipe [HLM 2.29] authorized under Automatic Board Order (ABO) issued as Permit No. 9472, 1974 - Ballard)) [Additional Reference(s): DWR Levee Log, 1992. USACE Sacramento O&M Manual 137, August 1955, (Station 120+00)]. FS Date: 5/19/2017 1:23:34 PM

View of levee crown looking downstream at crossing. CMP riser located on WS shoulder.

View of outlet located at WS toe.

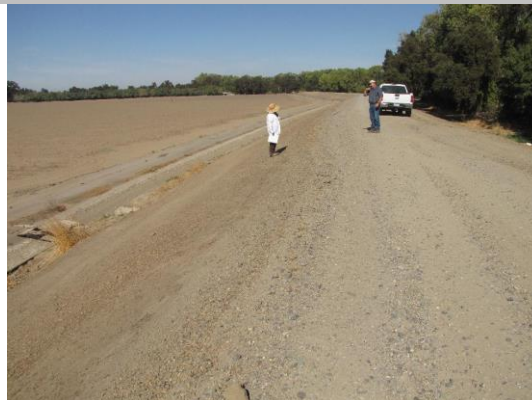
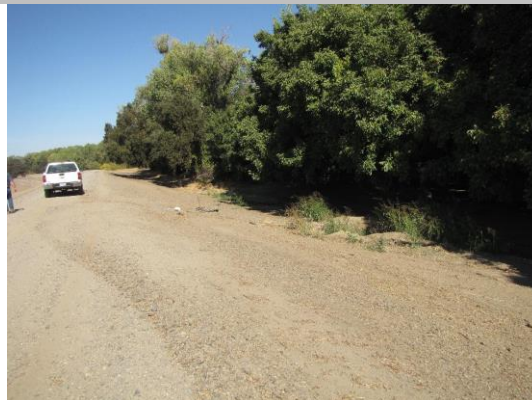
UCIP Comments: 5/3/2017 Sediment build up in WS pipe end. WS slide gate stem bent but it does not affect its operation. (DWR Sutter Yard- A Freitag)10/24/2016 WS slide gate stem is still bent.(DWR Sutter Yard- A Freitag)4/25/2016 WS slide gate is slightly bent. Rest of crossing appears to be in good condition. 4/20/2015 LS inlet still has some minor sediment build up. Needs to be cleaned.6/18/2014 Same as last inspection.12/17/2013 Same as last inspection.7/18/2013 WS slide gate looks to be in good condition but stem is slightly bent. Not sure if bend will hinder gates operation or not. LS inlet is still blocked by minor sediment build up.10/18/2012 LS pipe slightly deformed and sediment build up blocking about 30% of opening; need to check the condition of the slide gate-need photo. Metal marker down. This crossing was listed in the USACE Periodic Inspection as ID# USACE_CESPK_MA1C_2010_p_0187 for sediment build up at landward toe.

View of WS slope, riser with slide gate, and outlet.

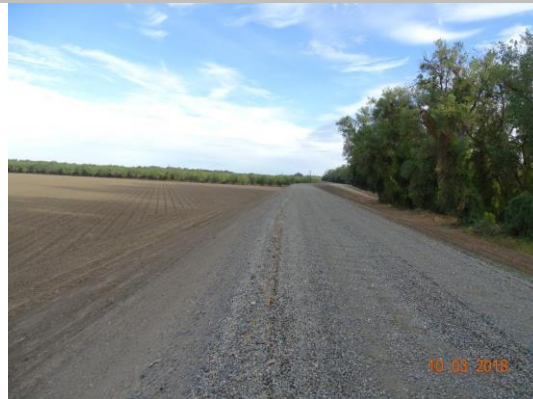
Photo 1 of 1 : FA_2018_MA0001_297_70_20181005_00151.jpg

LM Start	5.97	Rating **	A	Issue No.	70
LM End	5.97	Issue Type +	Ma	Location *	LS
Category	Earthen Levee			GPS Latitude/Longitude	
				Start	End
Item	Vegetation			39.275672 °	39.275672 °
				-122.023570 °	-122.023570 °
DWR ID	DWR_MA0001_01_f_2018_70				
Comment Code					
V1 : Control annual grass and weeds on the levee slopes and easements.					
Inspector Comment					
The LMA is doing an excellent job of managing the vegetation on the slopes of the levee in this area.

View of the levee with no vegetation on both slopes.

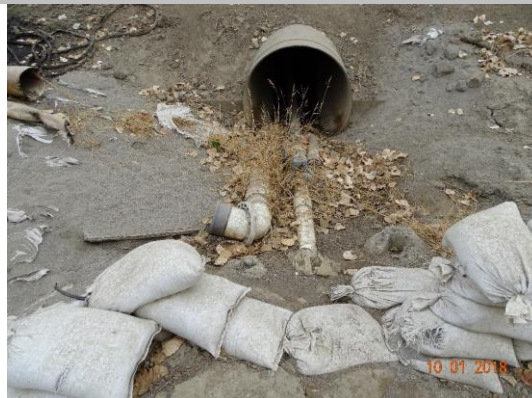
UCIP Comments: 10/1/2018 PVC pipe underneath the slide gate that is located inside CMP riser on WS shoulder was restored and blocks gate from closing. Sediment built up at the bottom of CMP riser. PVC pipe needs to be removed in order to properly close slide gate. (O.Yakimov - DWR)5/3/2017 Pipe leaked during the Jan/Feb 2017 high water event. Sand bags were placed at both the LS and WS outlets as well as down inside the standpipe to slow the water flow. The 5inch pvc was cut away but the slide gate could still not close fully. Suspect sediment build up was in the bottom of the stand pipe was blocking the gate. Inside of pipe should be cleaned out. (DWR Sutter Yard - AFreitag)10/24/2016 Pvc was back running through the crossing and blocking the screwgate. photo attached(DWR Sutter Yard - AFreitag)9/28/2016 Crossing has been downgraded from Urgent to Non-Urgent 5-inch PVC pipe was cut to allow the slide gate to close. Need to contact owner to remove unauthorized pipe to comply with Title 23. (DWR UCIP - omagana)4/25/2016 5 inch pvc pipe running through crossing has been cut out to allow the slide gate to close. (DWR Sutter Yard - afreitag)4/20/2015 5inch pvc is still present blocking slide gate from closing. WS end of pipe has been exposed so there is no way to stop water from flowing through pipe during highwater times. (DWR Sutter Yard - afreitag)6/23/2014 Same as last inspection. There is no way to stop water from flowing through pipe during high water times. (DWR Sutter Yard - afreitag)12/17/2013 Same as last inspection. (DWR Sutter Yard - afreitag)7/18/2013 Same as last inspection. (DWR Sutter Yard - afreitag)10/19/2012 Unauthorized 5 inch PVC pipe running through 36 inch crossing. 5 inch PVC crossing prevents slide gate from closing during high water. Debris and sediment inside riser. This crossing was listed in the USACE Periodic Inspection as ID# USACE_CESPK_MA1C_2010_p_0258 for 5 inch PVC pipe running through culvert. (DWR UCIP - omagana) FIELD_STRUCT_DESC: 36-inch steel (not corrugated metal, as referenced in O&M manual) drainage pipe through the levee, approximately 14-16 feet below levee crown. Slide gate in corrugated metal pipe (CMP) riser on the waterside (WS) slope. Pipe also visible on the landside (LS). [Additional Reference(s): DWR Levee Log, 1992. USACE Sacramento O&M Manual 137, August 1955, (Station 331+31)]. FS Date: 10/1/2018 2:59:44 PM

View of CMP riser at WS shoulder.

UCIP Comments: 10/1/2018 PVC pipe underneath the slide gate that is located inside CMP riser on WS shoulder was restored and blocks gate from closing. Sediment built up at the bottom of CMP riser. PVC pipe needs to be removed in order to properly close slide gate. (O.Yakimov - DWR)5/3/2017 Pipe leaked during the Jan/Feb 2017 high water event. Sand bags were placed at both the LS and WS outlets as well as down inside the standpipe to slow the water flow. The 5inch pvc was cut away but the slide gate could still not close fully. Suspect sediment build up was in the bottom of the stand pipe was blocking the gate. Inside of pipe should be cleaned out. (DWR Sutter Yard - AFreitag)10/24/2016 Pvc was back running through the crossing and blocking the screwgate. photo attached(DWR Sutter Yard - AFreitag)9/28/2016 Crossing has been downgraded from Urgent to Non-Urgent 5-inch PVC pipe was cut to allow the slide gate to close. Need to contact owner to remove unauthorized pipe to comply with Title 23. (DWR UCIP - omagana)4/25/2016 5 inch pvc pipe running through crossing has been cut out to allow the slide gate to close. (DWR Sutter Yard - afreitag)4/20/2015 5inch pvc is still present blocking slide gate from closing. WS end of pipe has been exposed so there is no way to stop water from flowing through pipe during highwater times. (DWR Sutter Yard - afreitag)6/23/2014 Same as last inspection. There is no way to stop water from flowing though pipe during high water times. (DWR Sutter Yard - afreitag)12/17/2013 Same as last inspection. (DWR Sutter Yard - afreitag)7/18/2013 Same as last inspection. (DWR Sutter Yard - afreitag)10/19/2012 Unauthorized 5 inch PVC pipe running through 36 inch crossing. 5 inch PVC crossing prevents slide gate from closing during high water. Debris and sediment inside riser. This crossing was listed in the USACE Periodic Inspection as ID# USACE_CESPK_MA1C_2010_p_0258 for 5 inch PVC pipe running through culvert. (DWR UCIP - omagana) FIELD_STRUCT_DESC: 36-inch steel (not corrugated metal, as referenced in O&M manual) drainage pipe through the levee, approximately 14-16 feet below levee crown. Slide gate in corrugated metal pipe (CMP) riser on the waterside (WS) slope. Pipe also visible on the landside (LS). [Additional Reference(s): DWR Levee Log, 1992. USACE Sacramento O&M Manual 137, August 1955, (Station 331+31)]. FS Date: 10/1/2018 2:59:44 PM

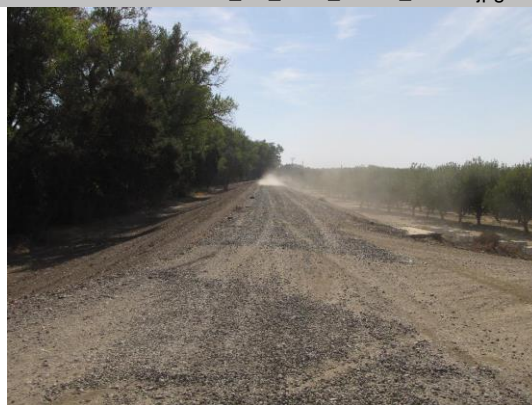
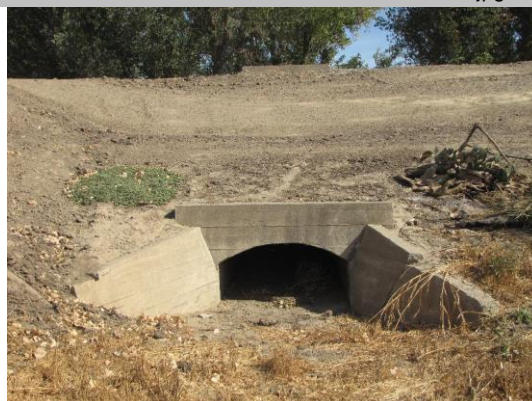
FS_ID:51874
DS_ID:16425
EP_NO: N/A
Repair Type: Non-Urgent
Crossing Status: Found
UCIP Comments: 5/3/2017 Abandoned- needs to be done properly.
(DWR Sutter Yard- AFreitag)10/24/2016 Abandoned(DWR Sutter Yard- AFreitag)4/25/2016 Abandoned crossing.4/20/2015 Same as last inspection.6/23/2014 Same as last inspection.12/17/2013 Same as last inspection.7/18/2013 Same as last inspection.10/19/2012 Need to be properly abandoned concrete structure; plate covers concrete box; Concrete headwall damaged. This crossing was listed in the USACE Periodic Inspection as ID# USACE_CESPK_MA1C_2010_p_0262 for damage to concrete structure (vertical 2 inch wide cracks and spalling visible).
FIELD_STRUCT_DESC: *ABANDONED* 72-inch corrugated metal (precast concrete) drainage pipe through the levee at an unknown depth below the crown. Structure is blocked on the waterside (WS) end with 3-foot concrete plug installed in 1980. Slide gate in concrete well on the landside (LS) shoulder. Concrete headwall at both toes. WS headwall not found. [Additional Reference(s): DWR Levee Log, 1992. USACE Sacramento O&M Manual 137, August 1955, (Station 339+74)].

View of WS no structure features visible.

View of structure located in LS.

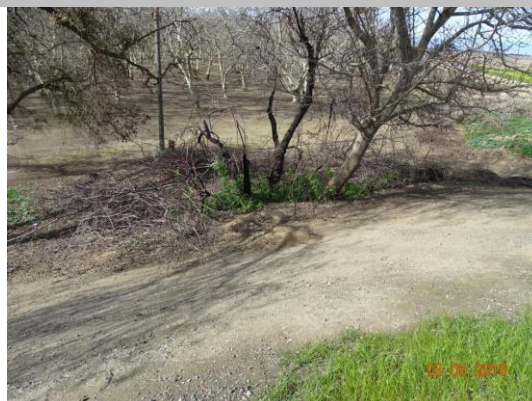
Photo 1 of 1 : FA_2018_MA0001_297_69_20180905_00016.jpg

View of the rodent holes along the landside slope.

LM Start	11.01	Rating **	M	Issue No.	69
LM End	11.01	Issue Type +	Ma	Location *	LS
Category	Earthen Levee			GPS Latitude/Longitude	
				Start	End
Item	Animal Control			39.340803 °	39.340803 °
				-122.032868 °	-122.032868 °
DWR ID	DWR_MA0001_01_s_2018_69				
Comment Code					
A3 : No rodents visible, but rodent burrows visible; need to backfill and compact or grout burrows.					
Inspector Comment					
Repair the rodent holes along the landside slope.
